### Selection of RCC Dam at Axis 2

# **Dam Foundation and Rock Borrow Area**

#### **CENTENNIAL RESERVOIR PROJECT Nevada Irrigation District**

#### **EXHIBITS**

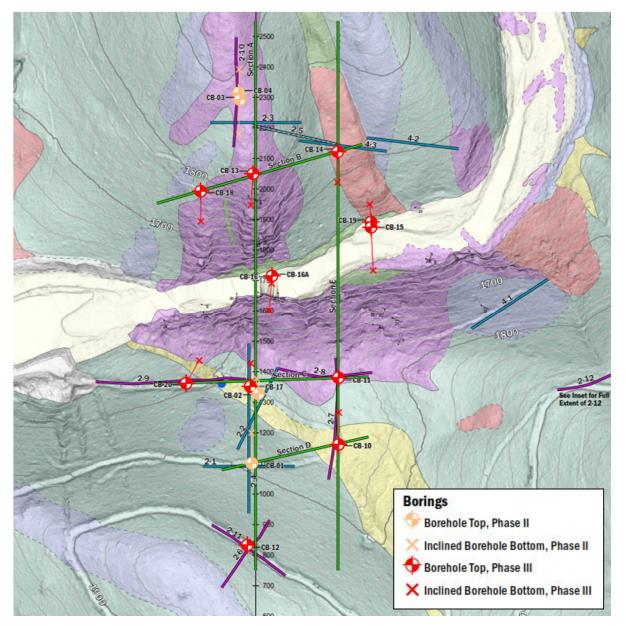
### **Site Exploration Map - Borings**

- 16 core borings
  - o 2 vertical
  - o 14 inclined
  - o Up to 254 feet deep
  - o Total drilling 2715 ft
- Water pressure (packer) testing
- Televiewer and caliper logging
- Downhole seismic velocities
- Rock strength testing

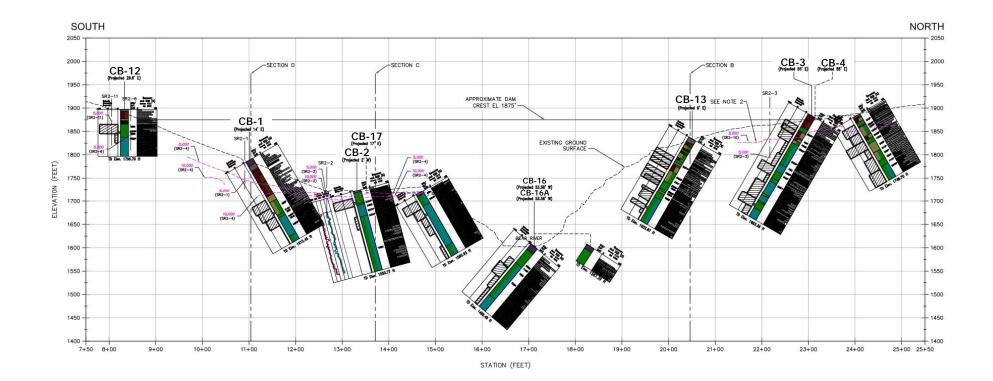
### **Geotechnical Profile - Axis 2**

- Depth to weathered rock generally less than 20 ft.
- Weathered rock found to depths of 100 130 ft. at some locations
- All borings encountered less fractured rock with depth
- Evaluation of significant joint sets and shears indicates a lack of persistence between adjacent bore holes
- Hydraulic conductivities mostly decrease with depth and with decreasing fracture intensity

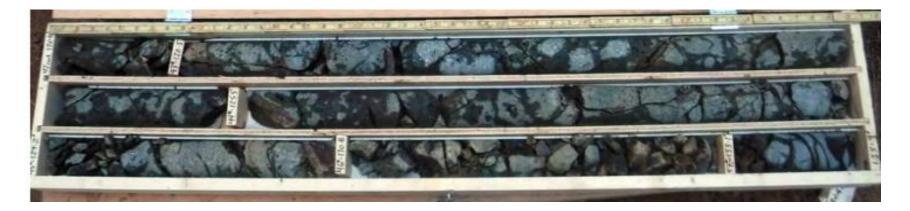
CB-1, 120.0 - 133.9 ft.

#### Core Boring Sample: south (left) abutment

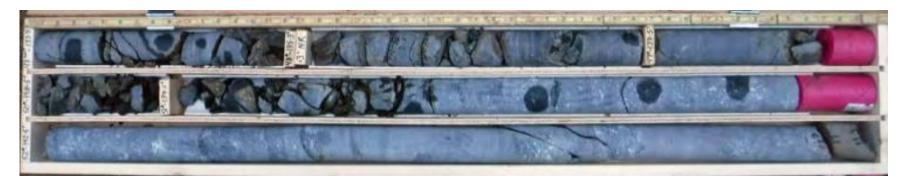
CB-1, 133.9 – 147.5 ft.

Ø Weathering and fracturing decrease with depth

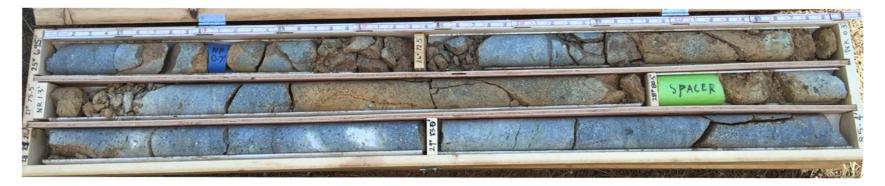
Rock Core: CB-13, 69.5 – 85.4 ft.

Rock Core and Televiewer Log: north (right) abutment

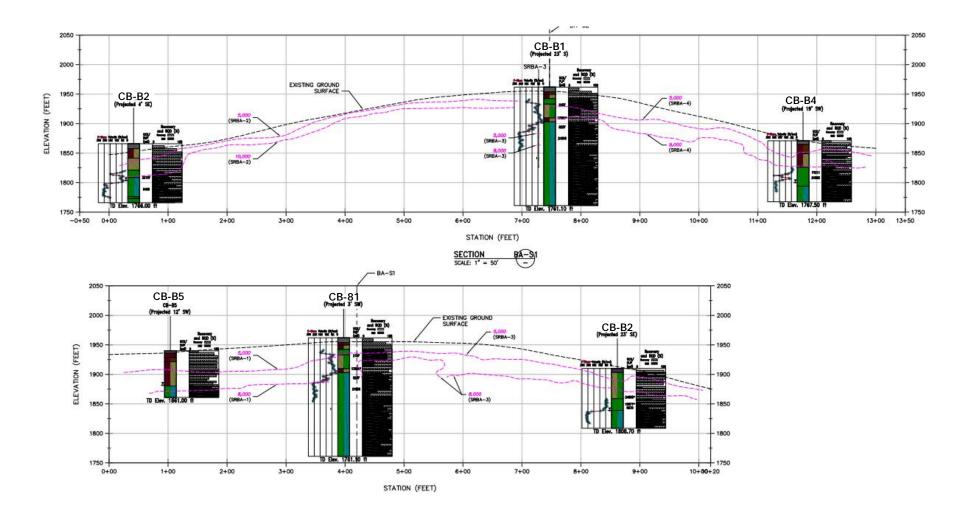
#### **Geotechnical Sections South Borrow Area**

- Hard basaltic rock
- Favorable topographic conditions
- Close to the dam site area

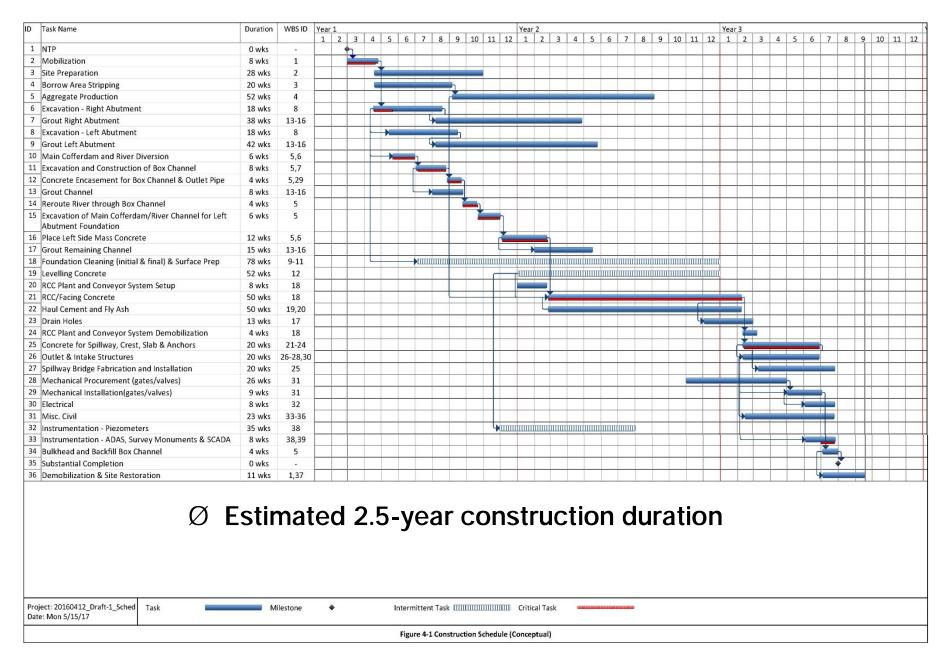
### **Construction Schedule (Conceptual)**

- Work performed up to 6 days per week, 2 shifts per day
- No overly restrictive constraints on trucking materials to the site
- Dam foundation excavation: 15,000 cy per week
- Foundation grouting (drilling and grouting): 600 If per week for each drill rig and grout plant.
- RCC construction: 16,000 cy per week
